**DEPARTMENT OF TRANSPORTATION**

Contract #: 04-0120F4Cty: SF/ALA Rte: 80 PM: 13.2/13.9File #: 99.28**WELDING INSPECTION REPORT****Resident Engineer:**Siegenthaler, Peter**Address:** 333 Burma Road**City:** Oakland, CA 94607**Report No:** WIR-025739**Date Inspected:** 17-Jul-2011**Project Name:** SAS Superstructure**OSM Arrival Time:** 1500**Prime Contractor:** American Bridge/Fluor Enterprises, a JV**OSM Departure Time:** 300**Contractor:** Zhenhua Port Machinery Company, Ltd (ZPMC) Chanxing Island **Location:** Shanghai, China**CWI Name:****CWI Present:****Yes No****Inspected CWI report:** **Yes No N/A****Rod Oven in Use:** **Yes No N/A****Electrode to specification:** **Yes No N/A****Weld Procedures Followed:** **Yes No N/A****Qualified Welders:** **Yes No N/A****Verified Joint Fit-up:** **Yes No N/A****Approved Drawings:** **Yes No N/A****Approved WPS:** **Yes No N/A****Delayed / Cancelled:** **Yes No N/A****Bridge No:** 34-0006**Component:** OBG 13BE, 13AW**Summary of Items Observed:**

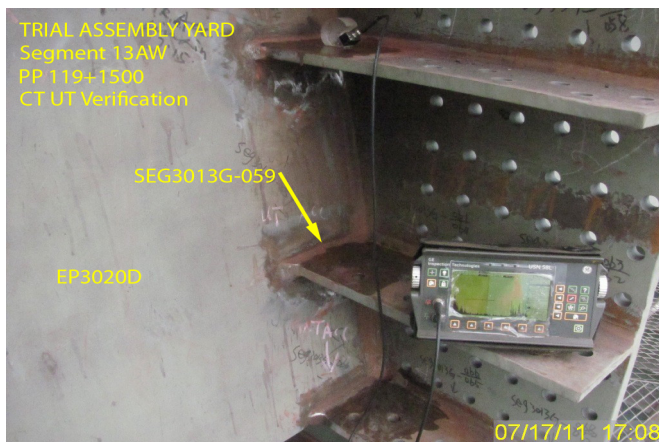
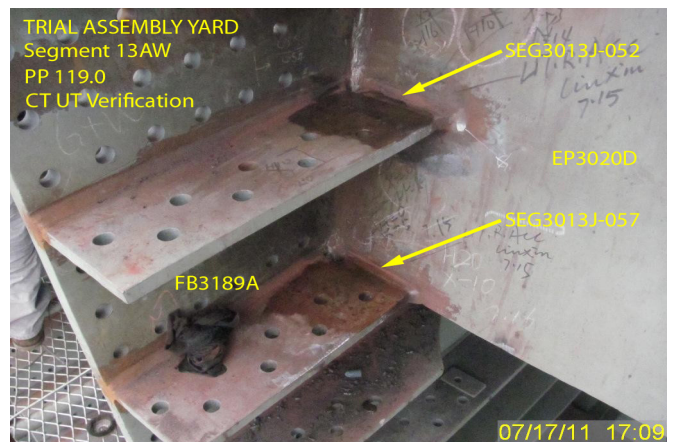
Unless otherwise noted, all work observed on this date appeared to generally comply with applicable contract documents.
